Raton Municipal Airport (RTN) Pavement Condition and Analysis

June 16, 2010 (FINAL)

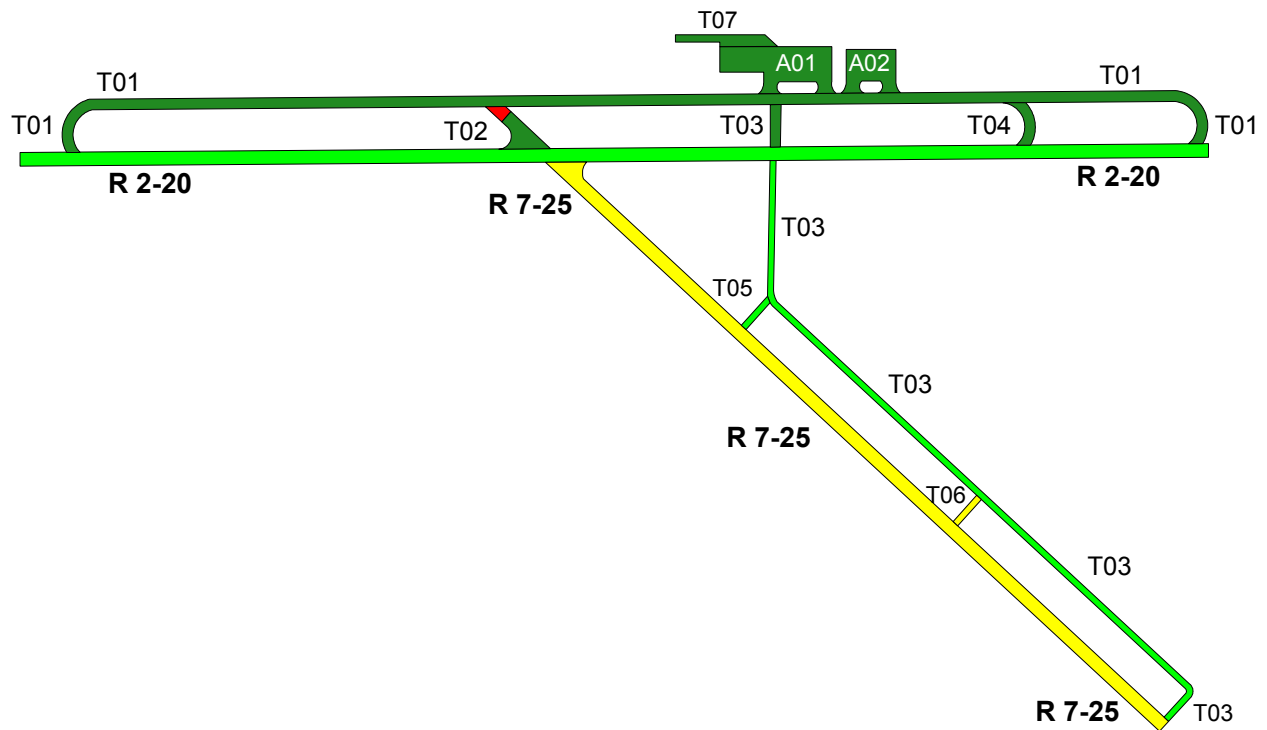
Figure 2. Raton Municipal Airport (RTN) PCI Branch Map, June 23, 2007

The asphalt concrete pavement on the runway, taxiways, and aprons was last inspected by New Mexico Tech (NMT) during June, 2007. Maps showing the general condition of these areas along with labels for the inspected areas are presented in Figures 2 and 3. Table 3 shows the results of the June, 2007 pavement inspection, and the 2010 pavement condition index (PCI) estimates.

Branch ID	Area [ft ²]	PCI 2007	PCI 2010
ALL*	1,552,575	81	71
Apron 1	106,725	89	81
Apron 2	52,500	97	77
Runway 2-20	492,450	79	69
Runway 7-25	330,300	68	57
Taxiway 1	268,600	88	80
Taxiway 2	37,375	68	58
Taxiway 3	215,000	88	80
Taxiway 4	9,600	94	88
Taxiway 5	7,000	83	74
Taxiway 6	6,825	66	54
Taxiway 7	26,200	87	79

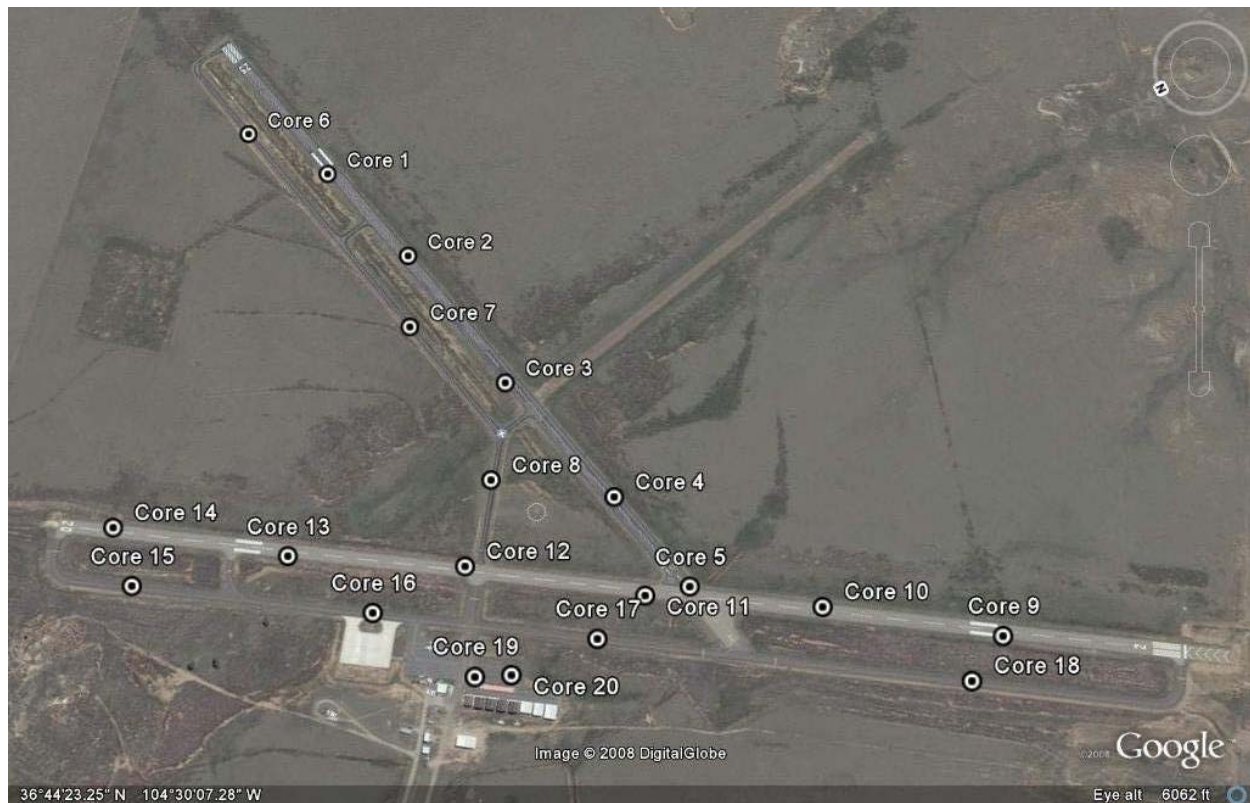
Figure 4. Borehole Locations at Raton Municipal Airport (RTN)

In March, 2009, the University of New Mexico (UNM) produced a report for the New Mexico Department of Transportation (NMDOT) – Aviation Division on the analysis of boreholes taken from the runways, taxiways and aprons at Raton Municipal Airport (RTN). The data consisted of asphalt concrete, base and subgrade thicknesses, generalized material compositions and California Bearing Ratio (CBR) for the materials underlying the pavement. In their analysis, samples from 20 boreholes were taken (Figure 4).

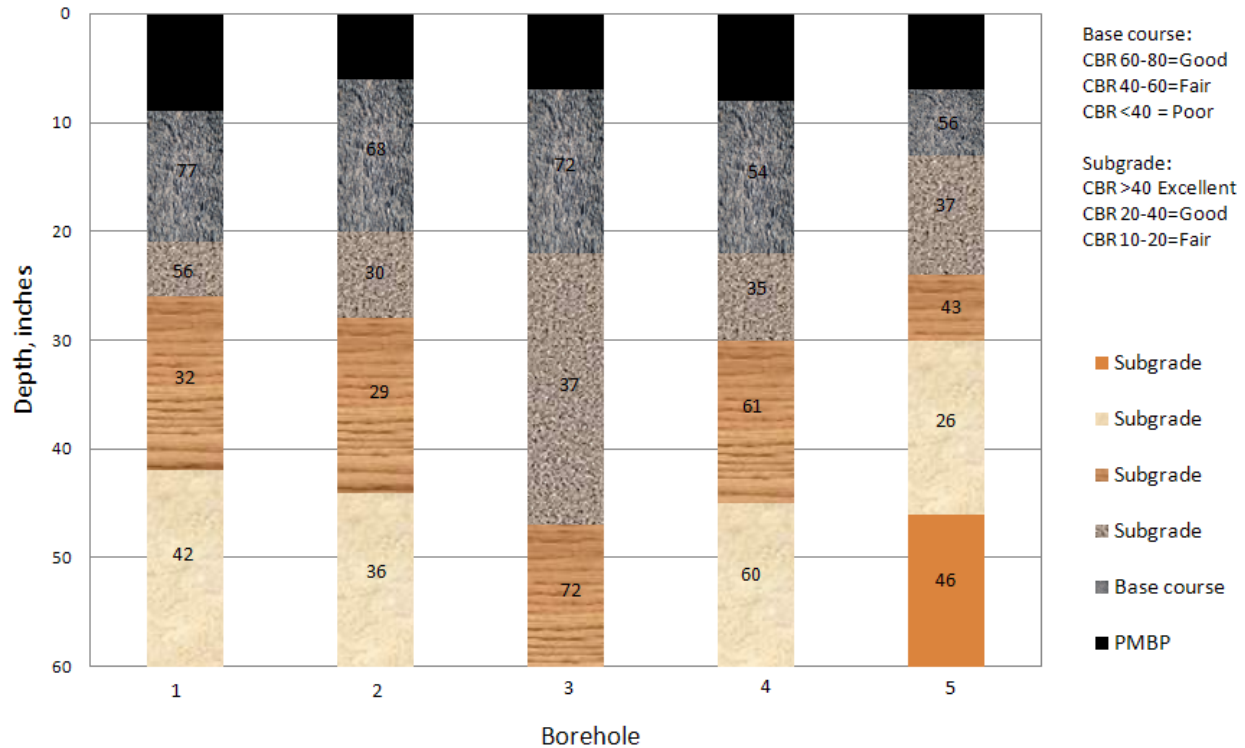
Figure 5. Base and Subgrade Analysis for Runway 7-25

Five borehole samples were taken on *Runway 7-25*. The average asphalt concrete depth was 7.4-inches. The average base thickness was 12-inches, and the material composition was found to be either well-graded gravel or well-graded sand. The average CBR of the base was measured to be 65, with a range of values from 54 to 77. Overall the CBR of the base material is considered to be good. The subgrade material was composed of well-graded sand, poorly-graded sand, silty clay, or poorly-graded gravel. The average CBR of the subgrade material was 43 (range of 26 to 72), which is good to excellent.

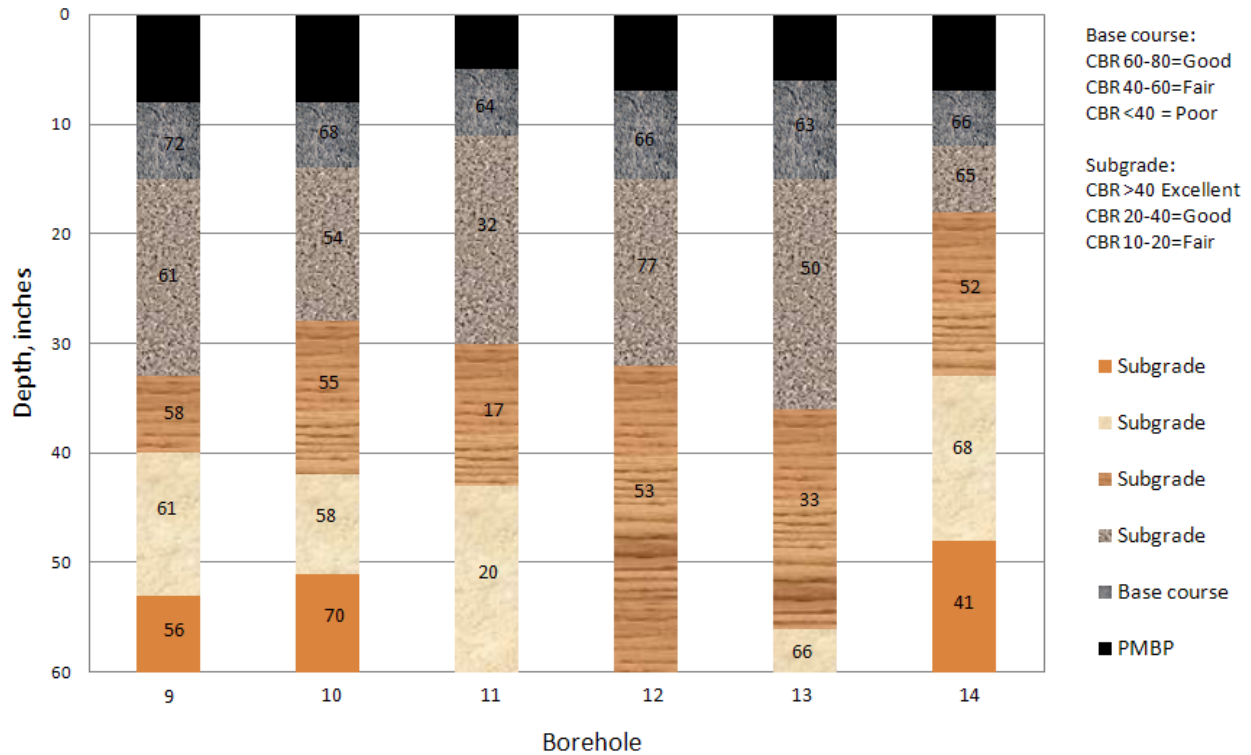
Figure 6. Base and Subgrade Analysis for Runway 2-20

Six borehole samples were taken on *Runway 2-20*. The average asphalt concrete depth was 6.8-inches. The average base thickness was nearly 7-inches, and the material composition was found to be well-graded gravel. The average CBR of the base was measured to be 67, with a range of values from 63 to 72. Overall the CBR of the base material is considered to be good. The subgrade material was composed of well-graded sand, poorly-graded sand, silty clay, or poorly-graded gravel. The average CBR of the subgrade material was 52 (range of 17 to 77), which is good to excellent.

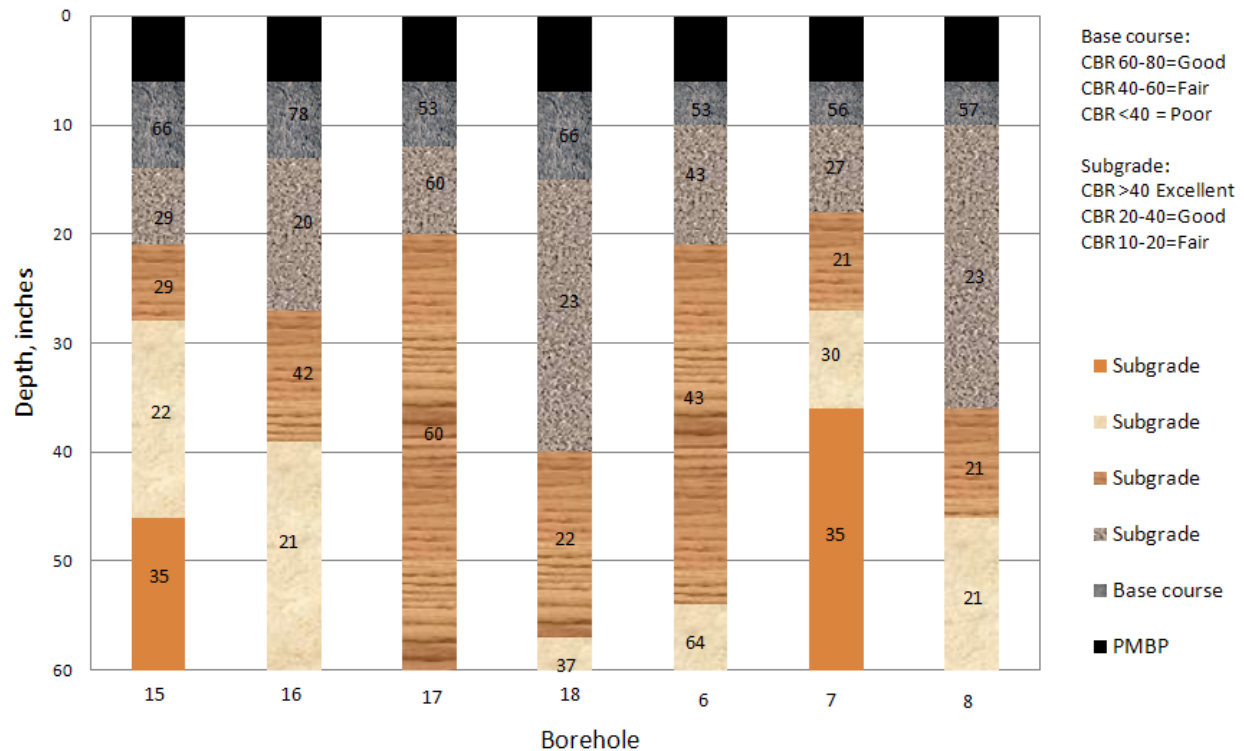
Figure 7. Base and Subgrade Analysis for Taxiways and Apron

Seven borehole samples were taken on *Taxiways A and B*. The average asphalt concrete depth was 6.1-inches. The average base thickness was nearly 6-inches, and the material composition was found to be well-graded gravel or poorly-graded sand. The average CBR of the base was measured to be 61, with a range of values from 53 to 78. Overall the CBR of the base material is considered to be good. The subgrade material was composed of poorly-graded sand, silty clay, or poorly-graded gravel. The average CBR of the subgrade material was 33 (range of 20 to 64), which is good to excellent.

Two borehole samples were taken on the *Aprons*. The average asphalt concrete depth was 2.5-inches. The average base thickness was 10-inches, and the material composition was found to be well-graded gravel or well-graded sand. The average CBR of the base was measured to be 59, with a range of values from 51 to 66. Overall the CBR of the base material is considered to be fair to good. The subgrade material was composed of poorly-graded sand, silty clay, or poorly-

graded gravel. The average CBR of the subgrade material was 50 (range of 35 to 64), which is good to excellent.

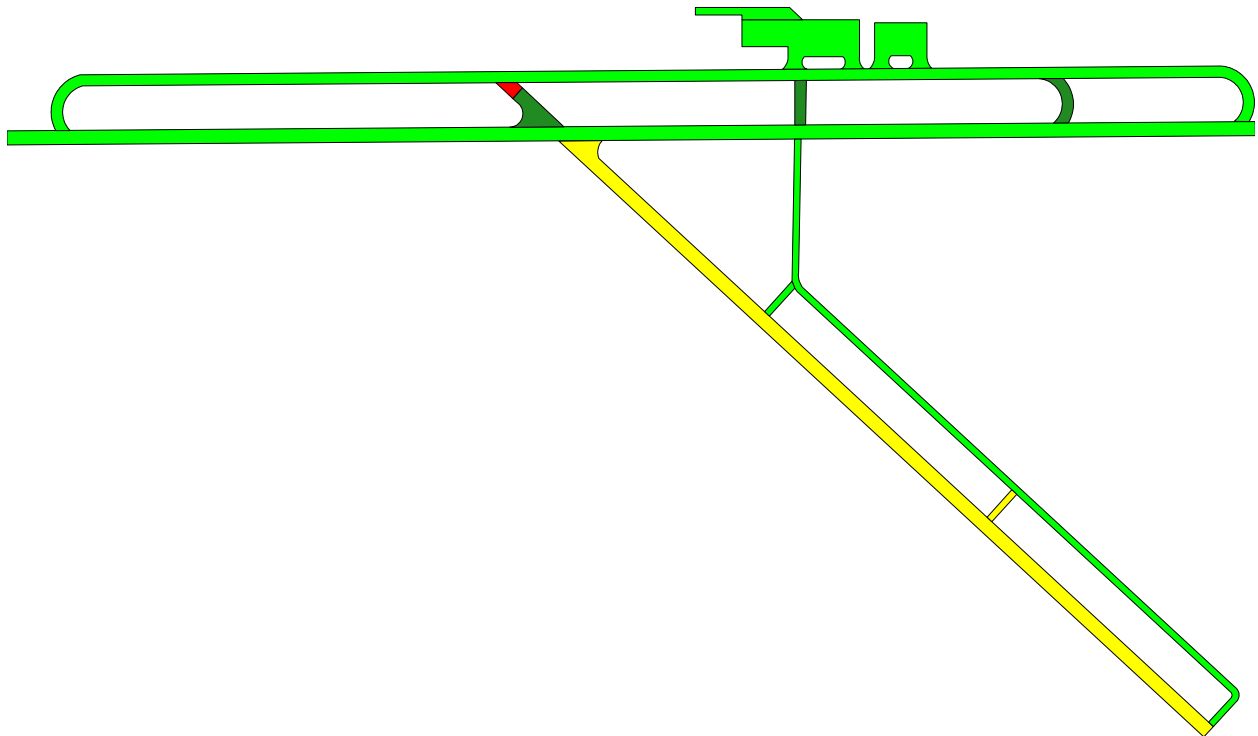
Figure 8. Raton Municipal Airport (RTN) Predicted PCI Branch Map for 2009

MicroPAVER 6 was used to predict the PCI values of the various pavement sections present at Raton Municipal Airport, assuming that no future maintenance occurs (Tables 4 and 8 and Figures 8-11). The pavement prediction relies on initial construction dates, when known, and the June, 2007 on-site pavement inspection. Additional inspection or construction data would increase the reliability of the predictive capabilities of the model.

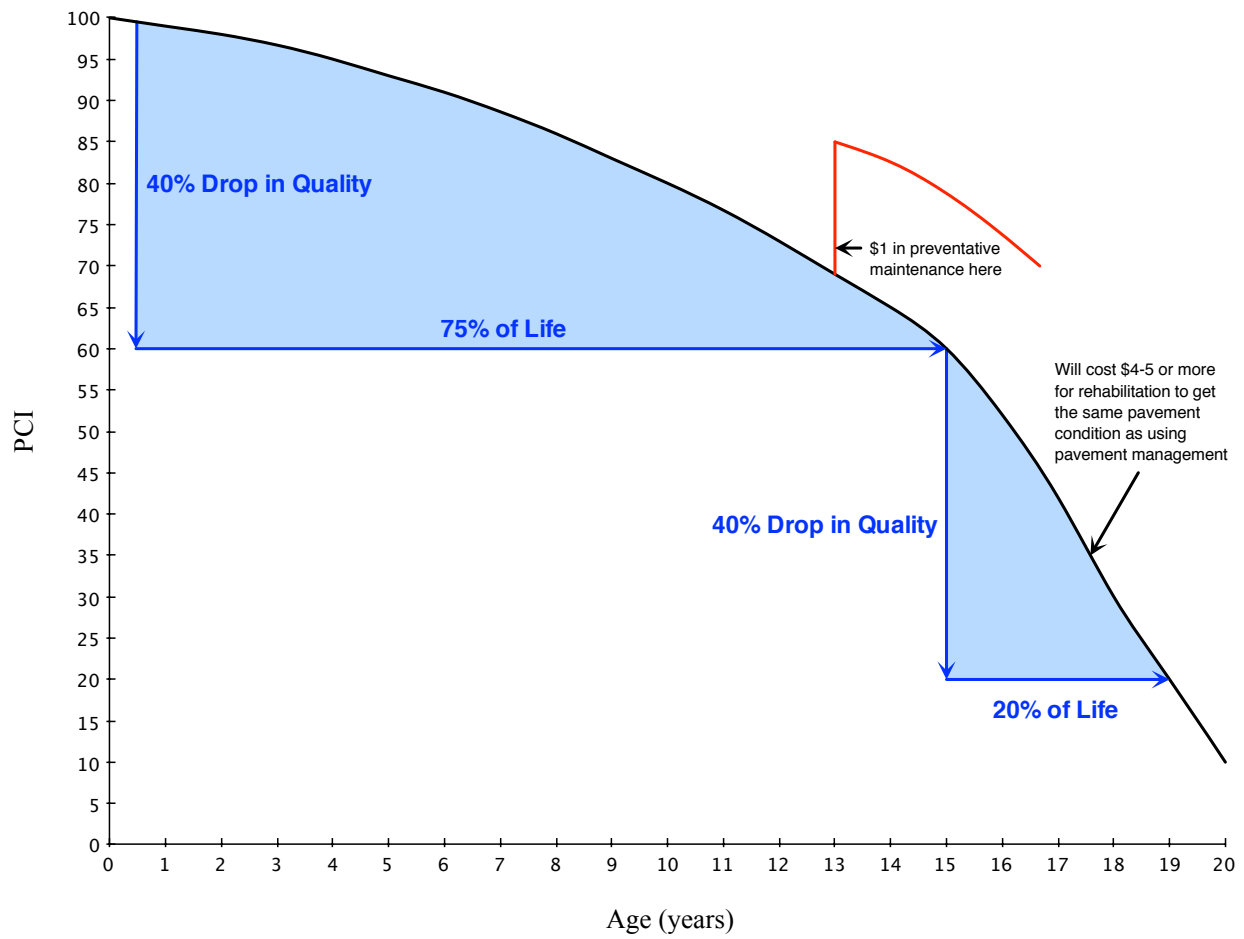
Figure 12. Typical Pavement Condition as a Function of Time

The FAA recommends a 20-year lifespan for asphalt concrete airport pavements. As shown in Figure 12, it is much more expensive to perform maintenance on pavements that have deteriorated below a Pavement Condition Index (PCI) of about 60. At this PCI, a major rehabilitation or reconstruction (mill and overlay) is required to substantially increase the PCI-value. This type of treatment would incur a much greater expense compared to rehabilitating pavements with PCI values greater than 60. Rehabilitation of pavements with PCI values below 60 can cost 4 to 5 times as much compared to the rehabilitation of pavements with PCI values greater than 60. It is generally accepted that the maintenance and rehabilitation of taxiways and aprons is of a lower priority than runways, so a lower PCI threshold of around 40 could be used. Therefore, funding priorities typically favor runways.
