Moriarty Municipal Airport (0E0) Pavement Condition and Analysis

Dr. Mark P. Cal, P.E.
Professor and Chair
Department of Civil & Environmental Engineering
801 Leroy Place, Jones Annex
Socorro, NM 87801
tel: (575) 835-5059
e-mail: mcal@nmt.edu

May 18, 2010 (FINAL)

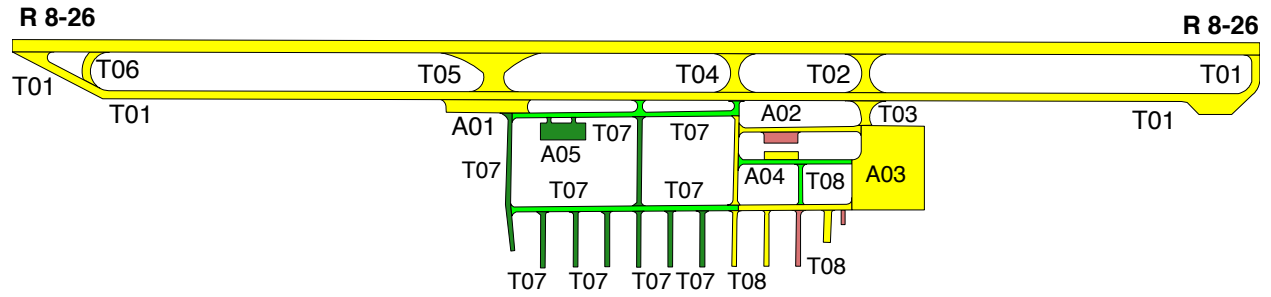
Figure 2. Moriarty Airport (0E0) PCI Branch Map, April 28, 2007

The asphalt concrete pavement on the runway, taxiways, and aprons was last inspected by New Mexico Tech (NMT) during April, 2007. Maps showing the general condition of these areas along with labels for the inspected areas are presented in Figures 2 and 3. Table 3 shows the results of the April, 2007 pavement inspection, and the 2010 pavement condition index (PCI) estimates, including maintenance completed at the airport in November, 2009, and detailed later in this report.

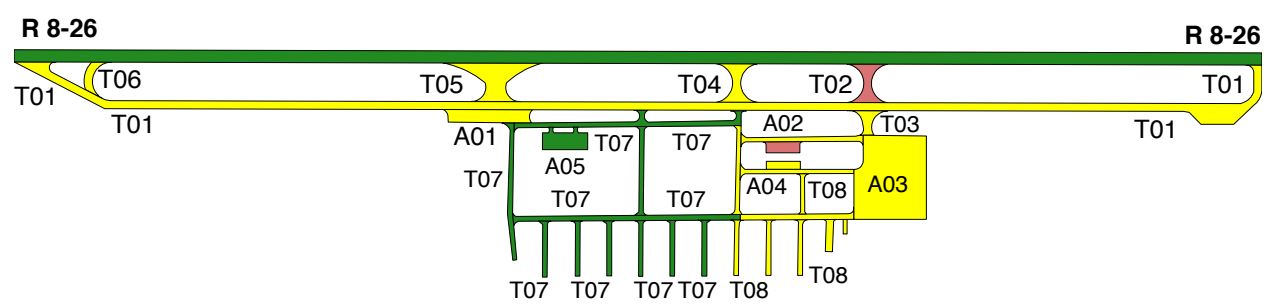
Figure 3. Moriarty Airport (0E0) PCI Branch Map, April, 2010

During November, 2009, Runway 8-26 at Moriarty (0E0) was resurfaced with a 3-inch mill and an asphalt concrete overlay. A coal tar seal was applied to the aprons and taxiways.

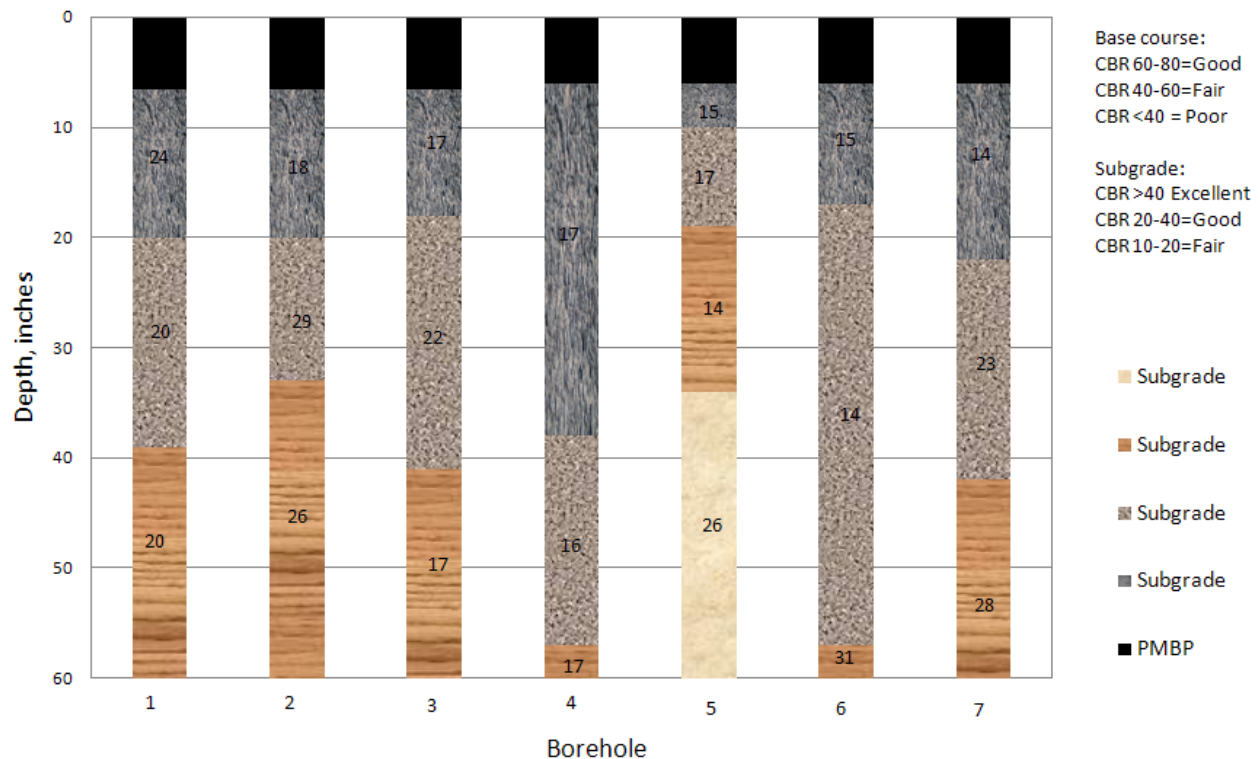
Figure 5. Base and Subgrade Analysis for Runway 8-26

Runway 8-26

Seven borehole samples were taken on *Runway 8-26*. The average asphalt concrete depth was 6-inches. If there was a granular base present under the runway, 6-inches of asphalt concrete would be much more than necessary (see the design section of this report). The asphalt concrete wearing surface was supported mainly by a mixture of silty sand. The average CBR of the silty sand subgrade material was about 21.

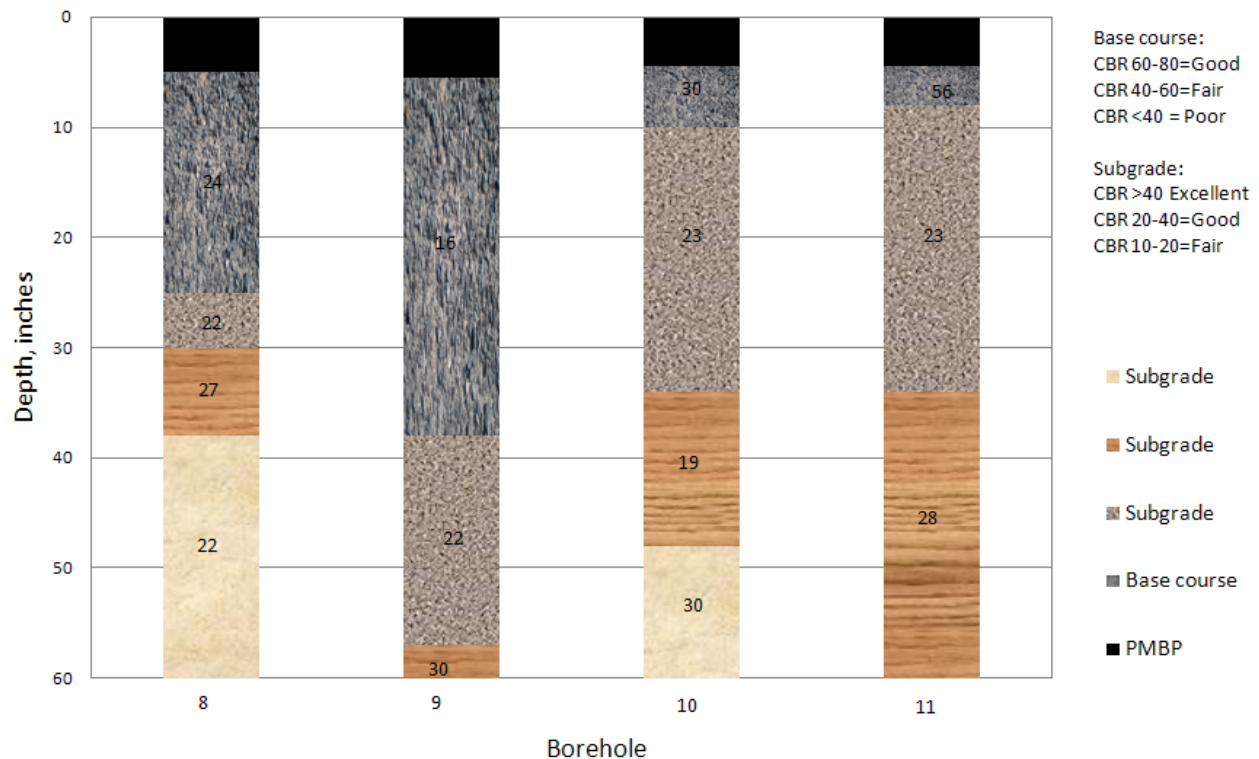
Figure 6. Base and Subgrade Analysis for Taxiway 1 and Apron 3

Three borehole samples were taken on *Taxiway 1*. The average asphalt depth on Taxiway 1 was 5-inches. The asphalt concrete wearing surface was supported mainly by a mixture of silty sand. The average CBR of the silty sand subgrade material was about 28.

One borehole sample were taken on the *Apron 3*, which is the largest apron. The average asphalt depth on Apron 1 was 5-inches. The asphalt concrete wearing surface was supported mainly by a mixture of silty sand. The average CBR of the silty sand subgrade material was about 28.

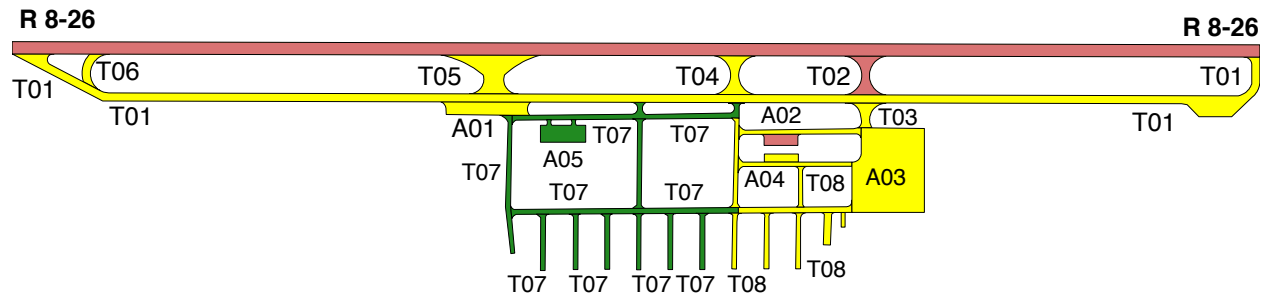
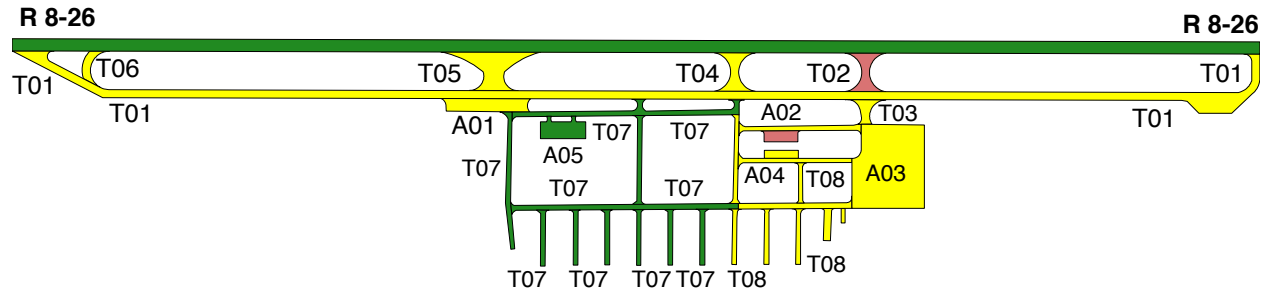
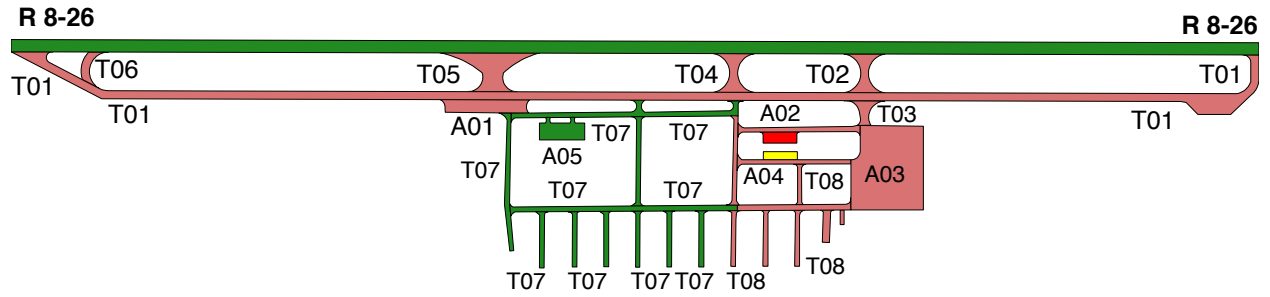
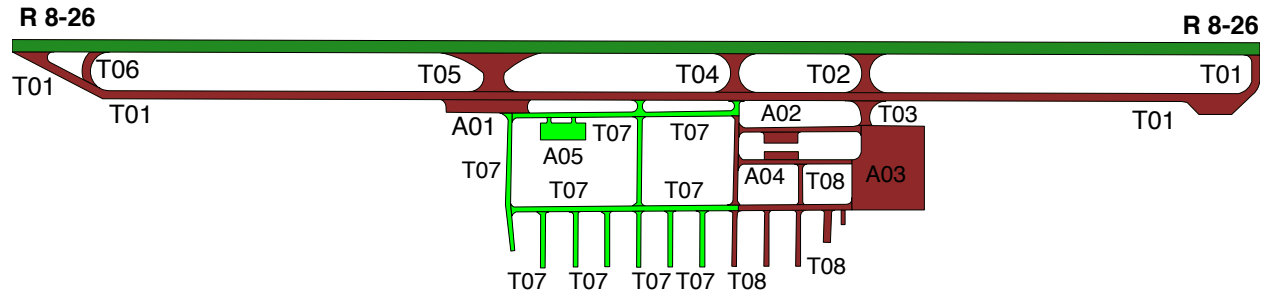
MicroPAVER 6 was used to predict the PCI values of the various pavement sections present at Moriarty Airport, assuming that no future maintenance occurs (Tables 5 and 9 and Figures 7-10). The pavement prediction relies on initial construction dates, when known, the April, 2007 on-site pavement inspection, and engineering judgement, as discussed in *Section 3*. Additional inspection or construction data would increase the reliability of the predictive capabilities of the model.
