Roswell International Air Center Airport (ROW) Pavement Condition and Analysis

Dr. Mark P. Cal, P.E.
Professor and Chair
Department of Civil & Environmental Engineering
801 Leroy Place, Jones Annex
Socorro, NM 87801
tel: (575) 835-5059
e-mail: mcal@nmt.edu

June 23, 2010 (FINAL)

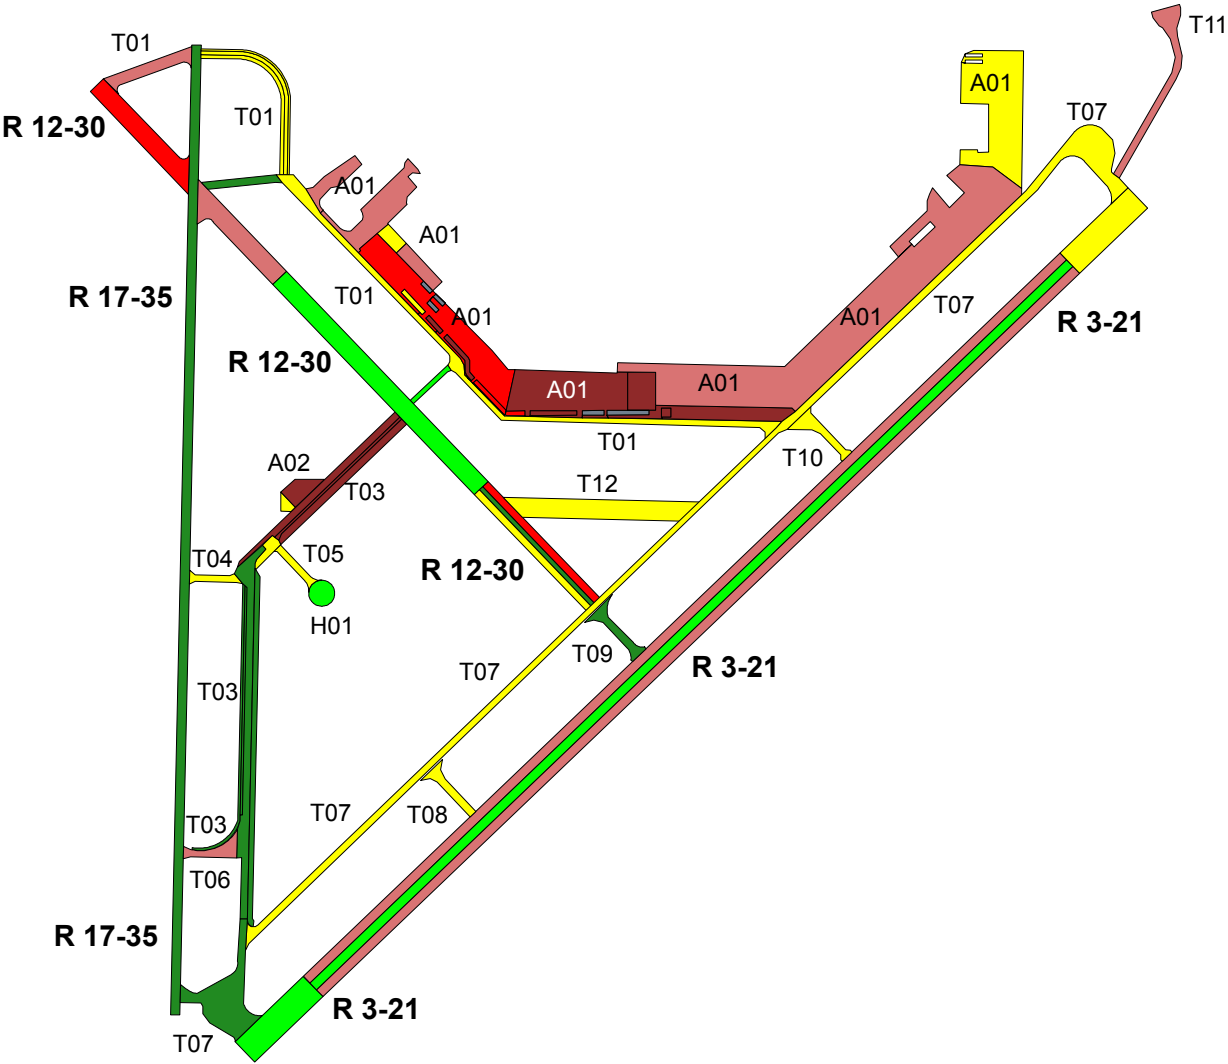
Figure 3. Roswell International Air Center (ROW) PCI Branch Map, March 14, 2007

The pavement surfaces on the runway, taxiways, and aprons was last inspected by New Mexico Tech (NMT) during March, 2007. The paved surfaces are a mixture of asphalt concrete (AC) and Portland cement concrete (PCC) (Table 3). A recent airport diagram is presented in Figure 2. Maps showing the general condition of these areas along with labels for the inspected areas are presented in Figures 3 and 4. Table 3 presents the results of the March, 2007 pavement inspection, and the 2010 pavement condition index (PCI) estimates.

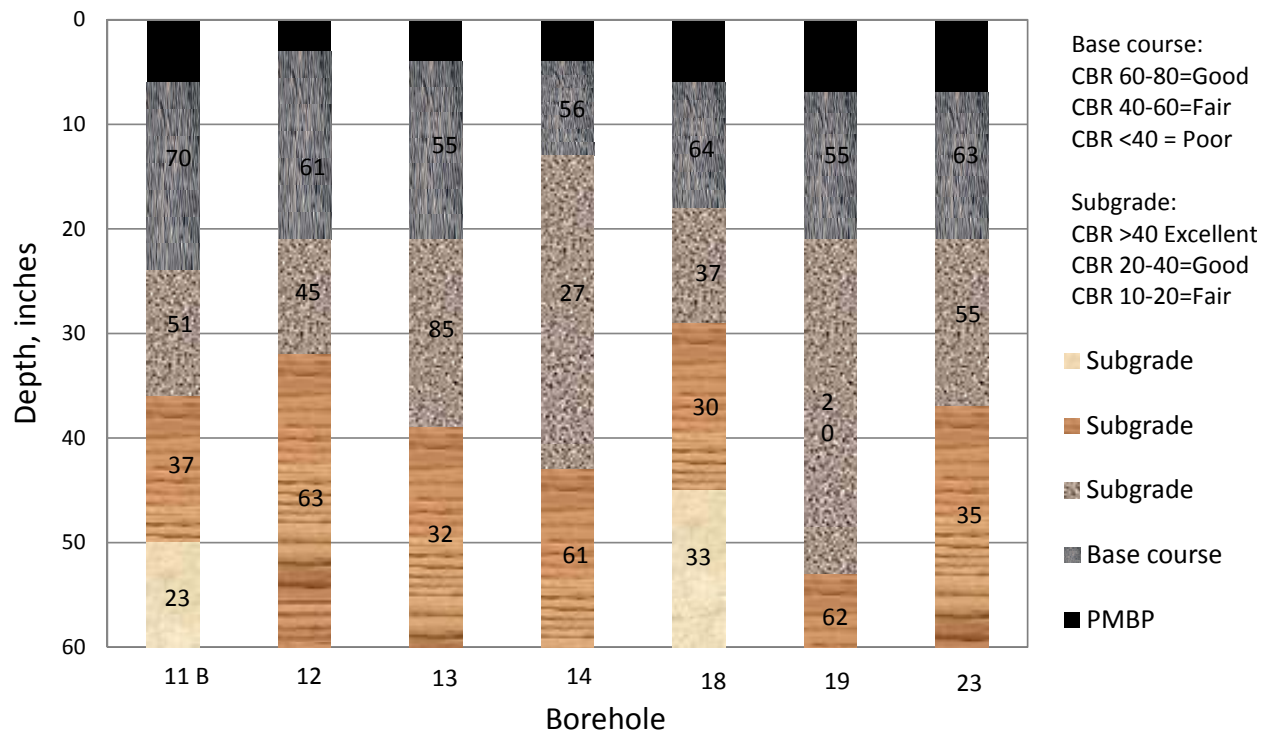
Figure 6. Base and Subgrade Analysis for Runway 3-21

Seven borehole samples were taken on *Runway 3-21*. The average asphalt concrete depth was 5.3-inches, and the average base thickness was 14.6-inches. The material composition of the base was found to be either poorly-graded gravel or poorly-graded sand. The average CBR of the base was measured to be 61, with a range of values from 55 to 70. Overall the CBR of the base material is considered to be good. The subgrade material was composed of a mixture of gravel, sand and silt. The average CBR of the subgrade material was 44 (range of 20 to 85), which is excellent.

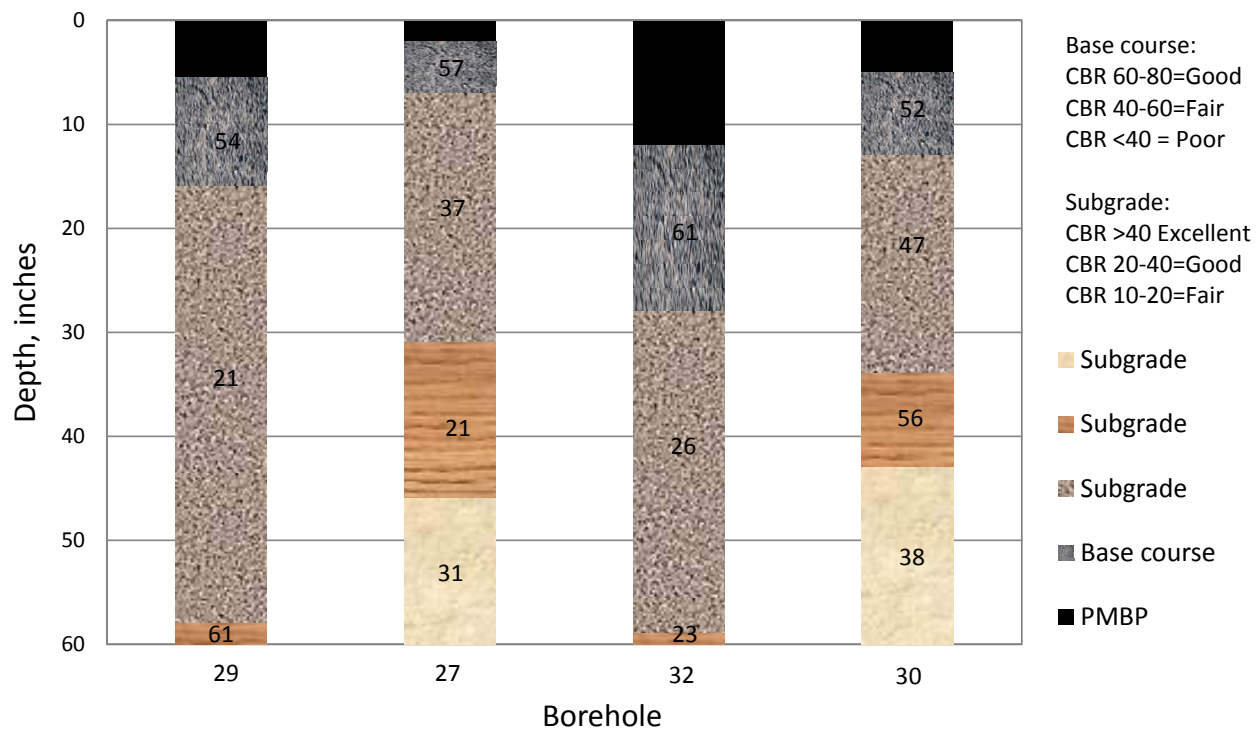
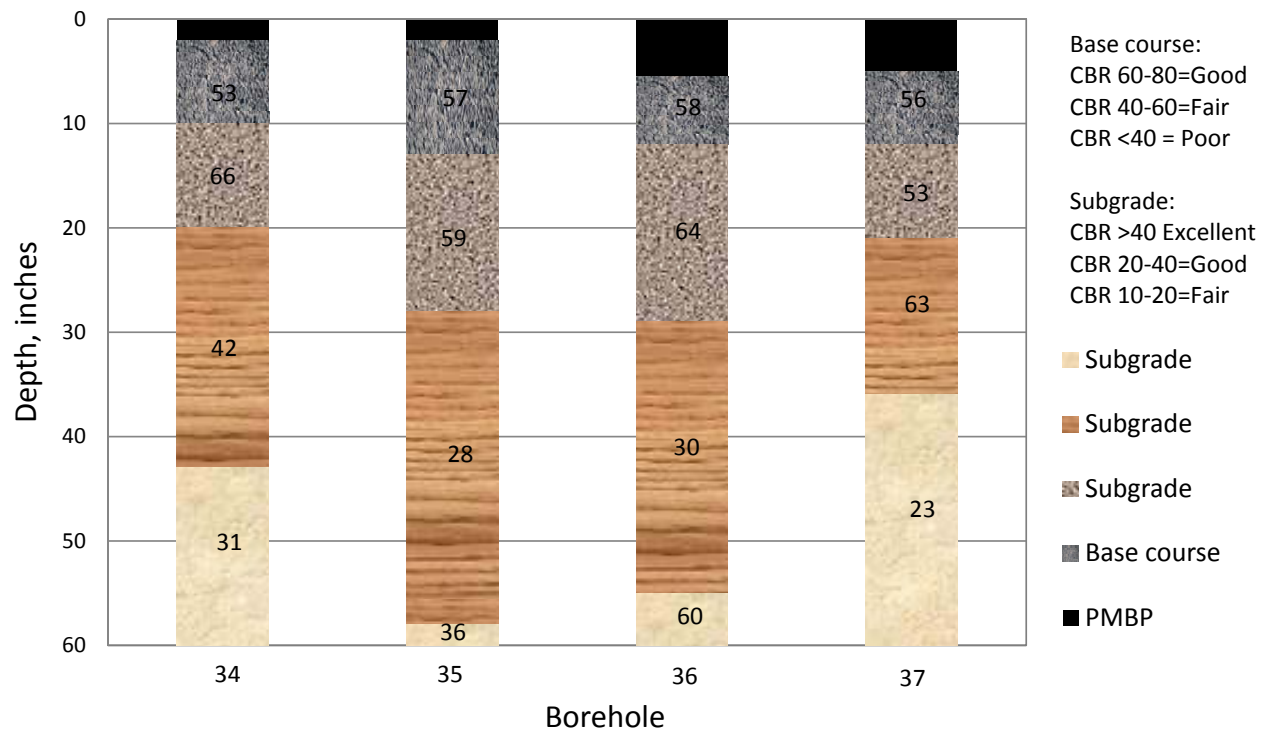
As part of the September, 2009 pavement and base analysis report, UNM examined Taxiways B, C, E, F and S and Apron A (Figures 7 and 8 and Table 4). Pavement construction of the taxiways varied greatly from 2 to 8.5 inches depth of asphalt concrete (Table 4).

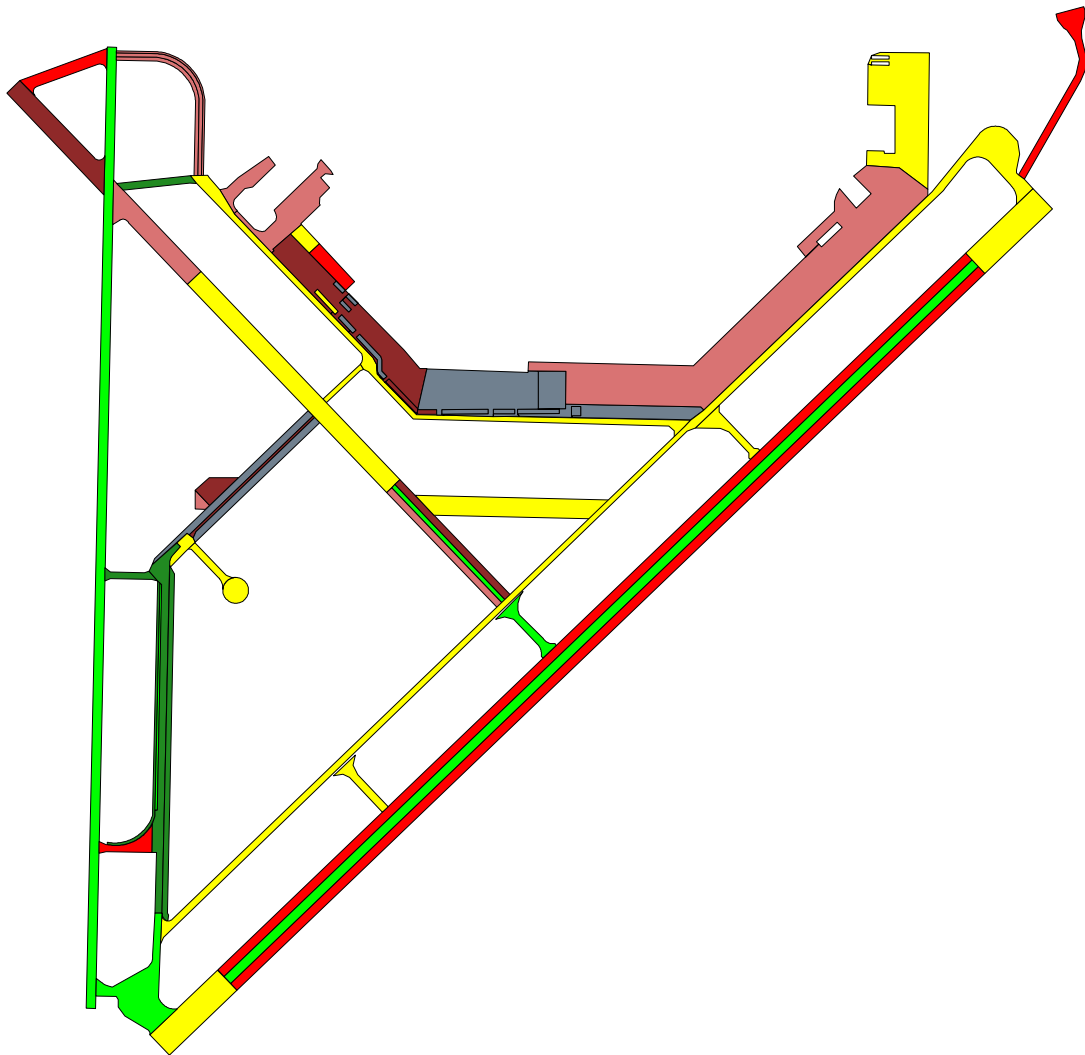
Figure 9. Roswell Intl. Air Center (ROW) Predicted PCI Branch Map for 2010

MicroPAVER 6 was used to predict the PCI values of the various pavement sections present at Roswell International Air Center (ROW), assuming that no future maintenance occurs after 2010 (Tables 5 and 10 and Figures 9-11). The pavement prediction relies on initial construction dates, when known, and the March, 2007 on-site pavement inspection and construction that occurred during December, 2009. Additional inspection, construction or history data would increase the reliability of the predictive capabilities of the model.
