# **Sierra Blanca Ruidoso Airport (SRR) Pavement Condition and Analysis**

June 10, 2010 (FINAL)

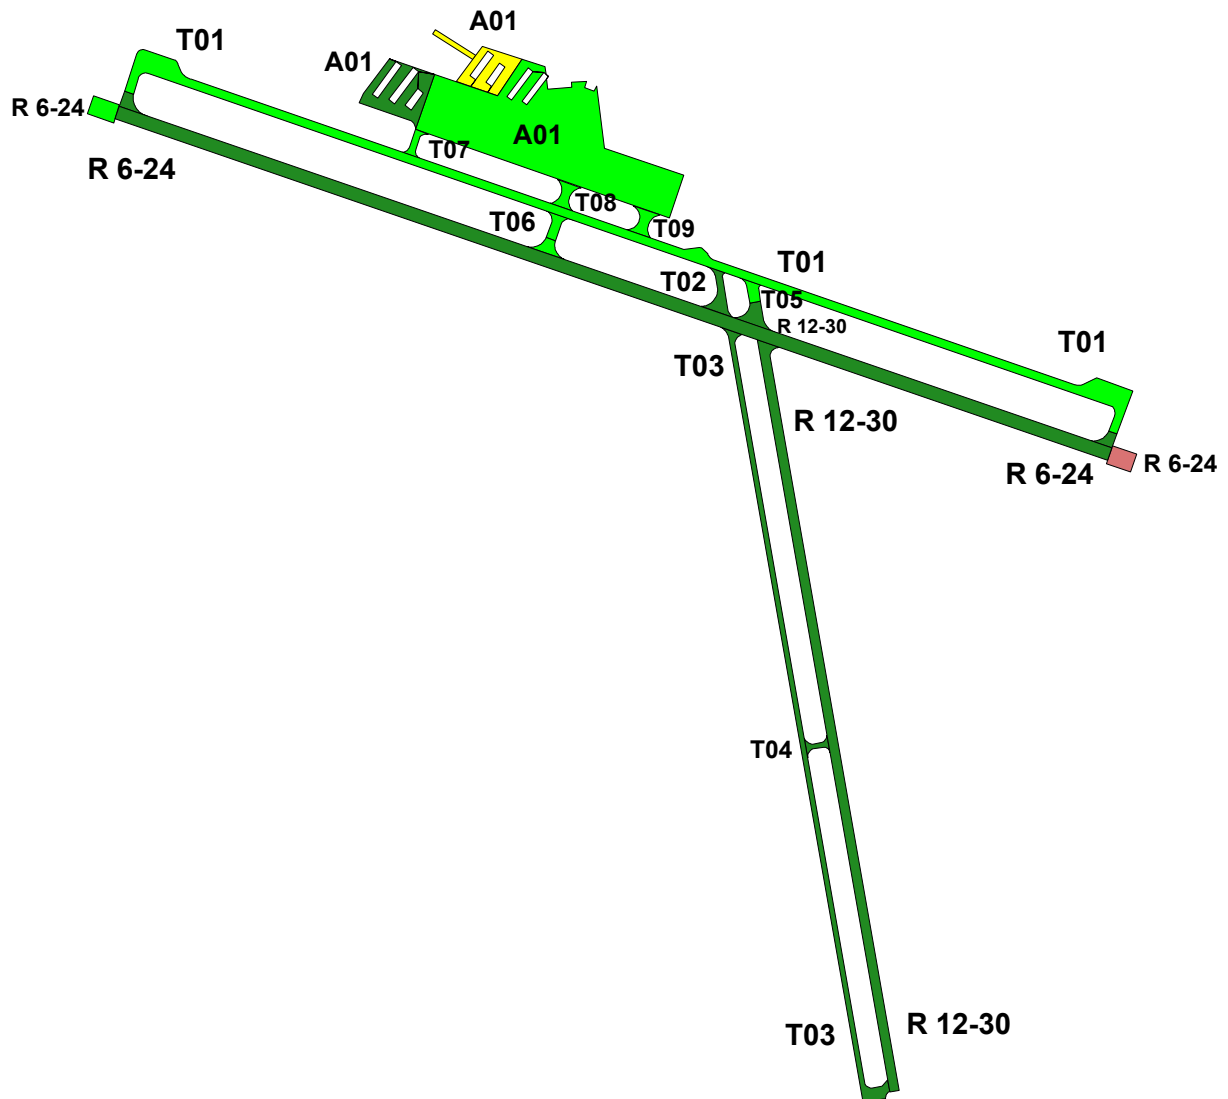
Figure 2. Sierra Blanca Ruidoso (SRR) PCI Branch Map, March 10, 2007

The asphalt concrete pavement on the runways, taxiways, and aprons was last inspected by New Mexico Tech (NMT) during March, 2007. Maps showing the pavement condition index (PCI) of these areas along with labels for the inspected areas are in presented in Figures 2 and 3.

Branch ID	Area [ft <sup>2</sup> ]	PCI 2007	PCI 2010
ALL*	3,620,860	79	70
Apron 01	1,364,350	75	64
Runway 6-24	872,800	72	61
Runway 12-30	453,100	89	81
Taxiway 01	601,960	88	81
Taxiway 02	18,900	93	87
Taxiway 03	231,750	90	83
Taxiway 04	5,250	94	88
Taxiway 05	12,750	84	75
Taxiway 06	21,000	85	76
Taxiway 07	10,000	81	72
Taxiway 08	14,000	80	71
Taxiway 09	15,000	81	72

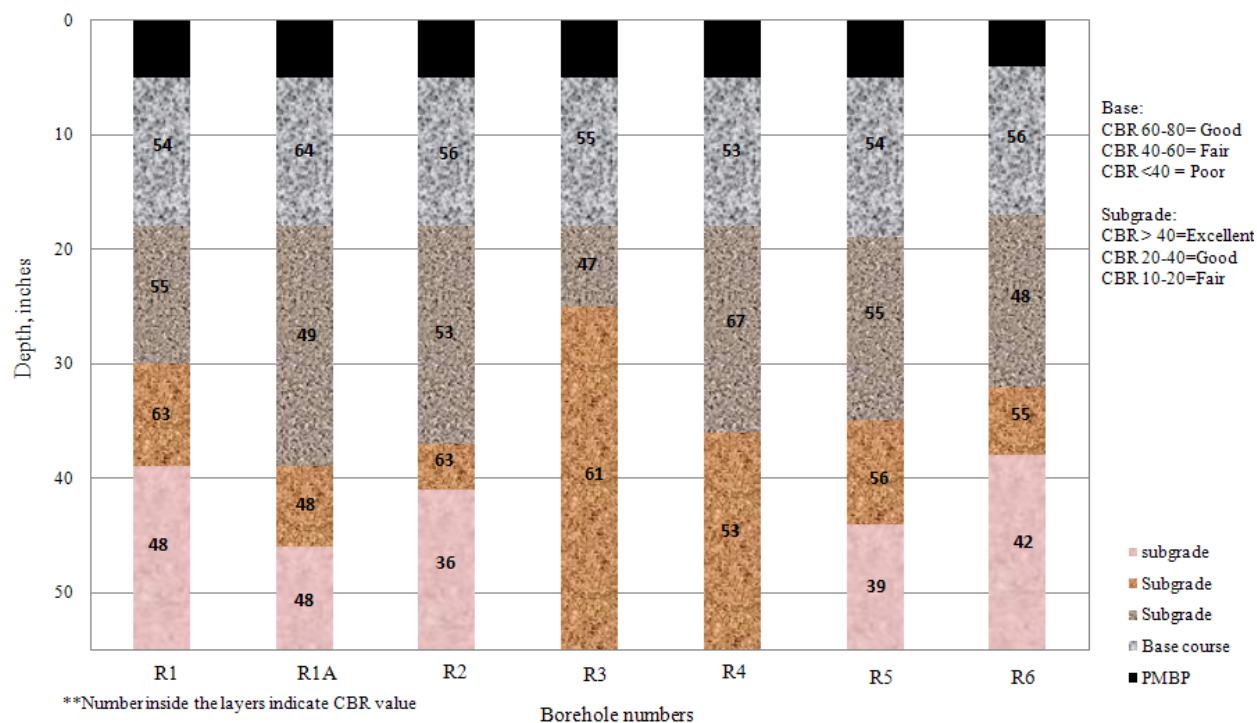
**Figure 5. Base and Subgrade Analysis for Runway 12-30**

Seven borehole samples were taken on Runway 12-30. The average asphalt concrete depth was 4.9-inches. The average base depth was about 13-inches, which is acceptable as a support for asphalt concrete pavement and the design aircraft traffic (see the design section of this report). The CBR for the subgrade material was very good to excellent (range of 36-67 and an average of 52).

Using the design aircraft traffic specified in Table 5, and the data obtained from borehole analysis of the runways, Runway 12-30 was adequately designed for a lifetime of 20 years, assuming that the design load capacity is not greatly exceeded. Since there are two runways present at Sierra Blanca Ruidoso (SRR) Airport, both runways should have aircraft traffic less than the design values presented in Table 5.

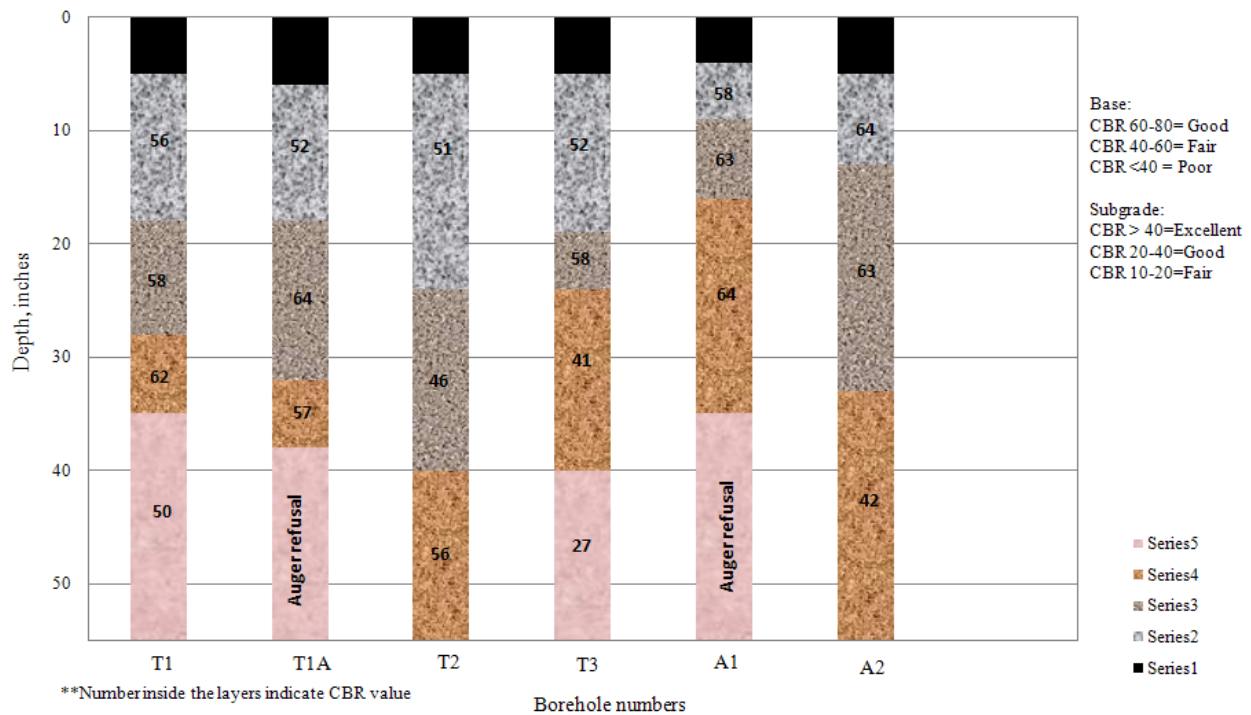
**Figure 6. Base and Subgrade Analysis for Taxiways and Aprons**

Four borehole samples were taken on Taxiway B. The average asphalt depth on Taxiway 1 was 5.3-inches. The average base depth was about 14.5-inches. The CBR for the base material is generally fair (average of 53). The subgrade material is good to excellent (average of 52).

Two borehole samples were taken on Apron 1. The average asphalt depth on the aprons was 4.5-inches. The average base depth was about 30-inches, which is more than acceptable as a support for asphalt concrete pavement and the design aircraft (see the design section of this report). The CBR for the base material is in the range of fair to good (average of 61). The subgrade material is excellent (average of 42).

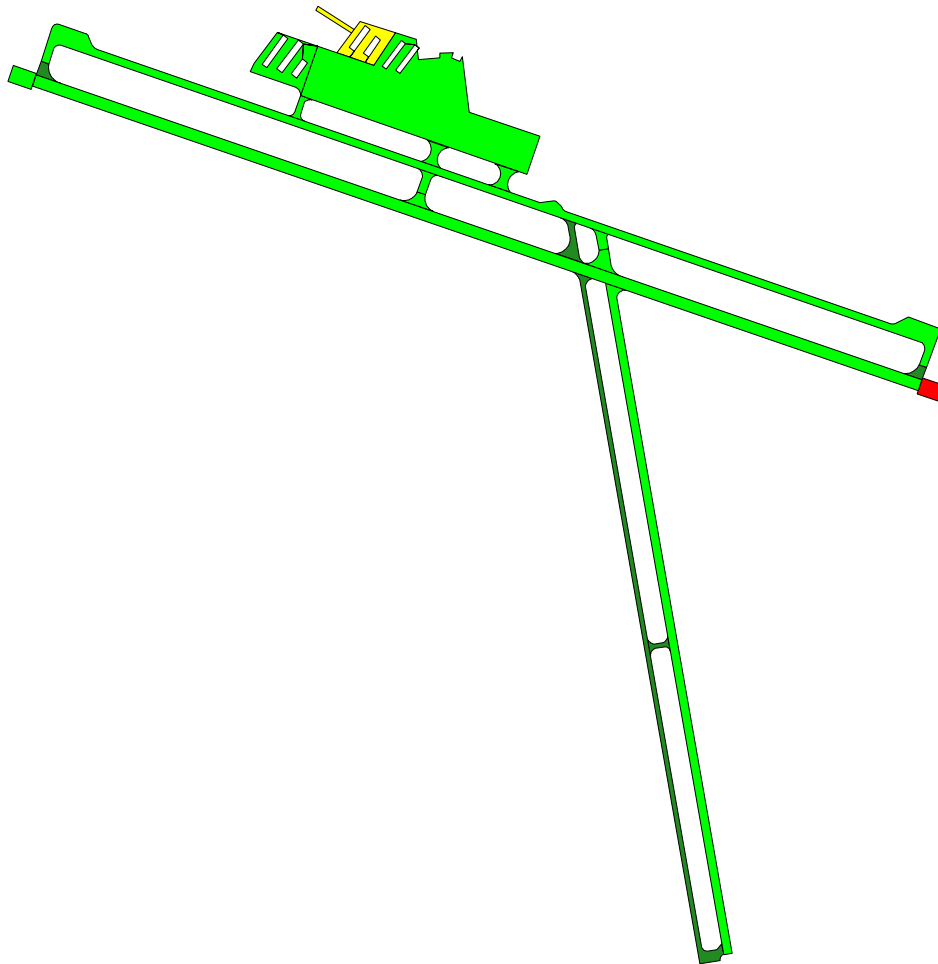
**Figure 7. Sierra Blanca Ruidoso (SRR) Predicted PCI Map for 2009**

*MicroPAVER 6* was used to predict the PCI values of the various pavement sections present at the Sierra Blanca Ruidoso (SRR) airport, assuming that no future maintenance occurs (Tables 4 and 9 and Figures 7-10). The pavement prediction relies on initial construction dates, when known, and the 2007 on-site pavement inspection. Additional inspection or construction data would increase the reliability of the predictive capabilities of the model.
