Moriarty Municipal Airport (0E0) Pavement Condition and Analysis

Dr. Mark P. Cal, P.E.
Professor and Chair
Department of Civil & Environmental Engineering
801 Leroy Place, Jones Annex
Socorro, NM 87801
tel: (575) 835-5059
e-mail: mcal@nmt.edu

May 18, 2010 (FINAL)

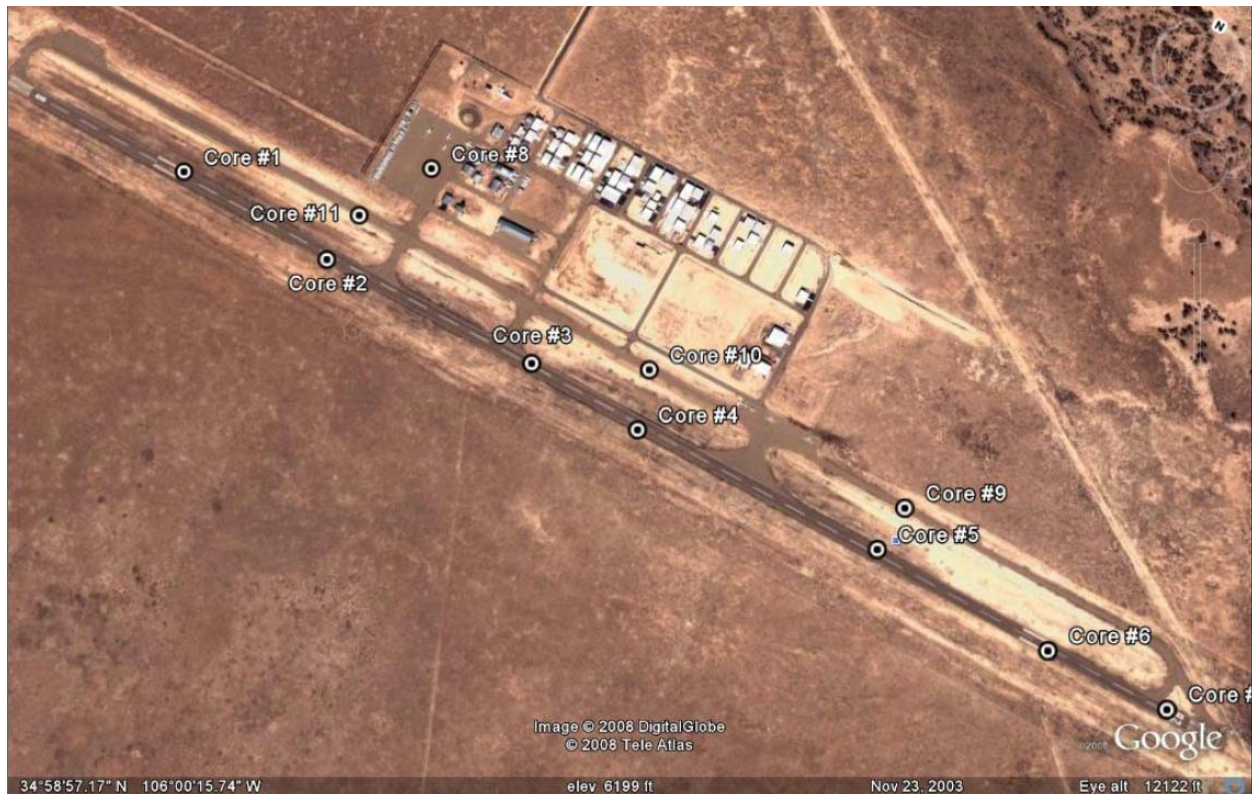
Figure 4. Borehole Locations at Moriarty Airport (0E0)

In March, 2009, the University of New Mexico (UNM) produced a report for the New Mexico Department of Transportation (NMDOT) – Aviation Division on the analysis of boreholes taken from the runways, taxiways and aprons at Moriarty Airport (0E0). The data consisted of asphalt concrete, base and subgrade thicknesses, generalized material compositions and California Bearing Ratio (CBR) for the materials underlying the pavement. In their analysis, samples from 11 boreholes were taken, and most of their locations are shown in Figure 4.

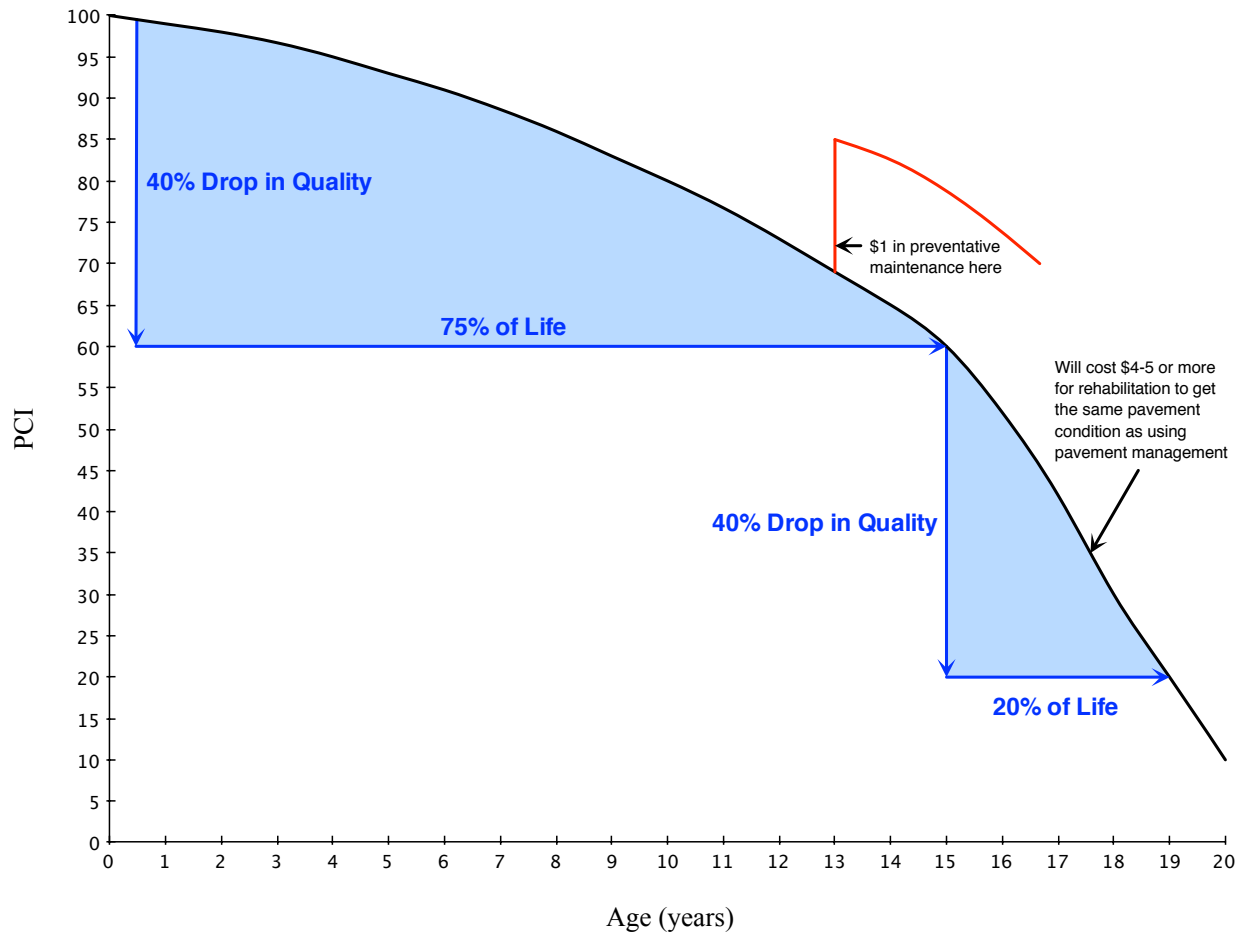
Figure 11. Typical Pavement Condition as a Function of Time

The FAA recommends a 20-year lifespan for asphalt concrete airport pavements. As shown in Figure 11, it is much more expensive to perform maintenance on pavements that have deteriorated below a Pavement Condition Index (PCI) of about 60. At this PCI, a major rehabilitation or reconstruction (mill and overlay) is required to substantially increase the PCI-value. This type of treatment would incur a much greater expense compared to rehabilitating pavements with PCI values greater than 60. Rehabilitation of pavements with PCI values below 60 can cost 4 to 5 times as much compared to the rehabilitation of pavements with PCI values greater than 60. It is generally accepted that the maintenance and rehabilitation of taxiways and aprons is of a lower priority than runways, so a lower PCI threshold of around 40 could be used. Therefore, funding priorities typically favor runways.
