# **Sierra Blanca Ruidoso Airport (SRR) Pavement Condition and Analysis**

June 10, 2010 (FINAL)

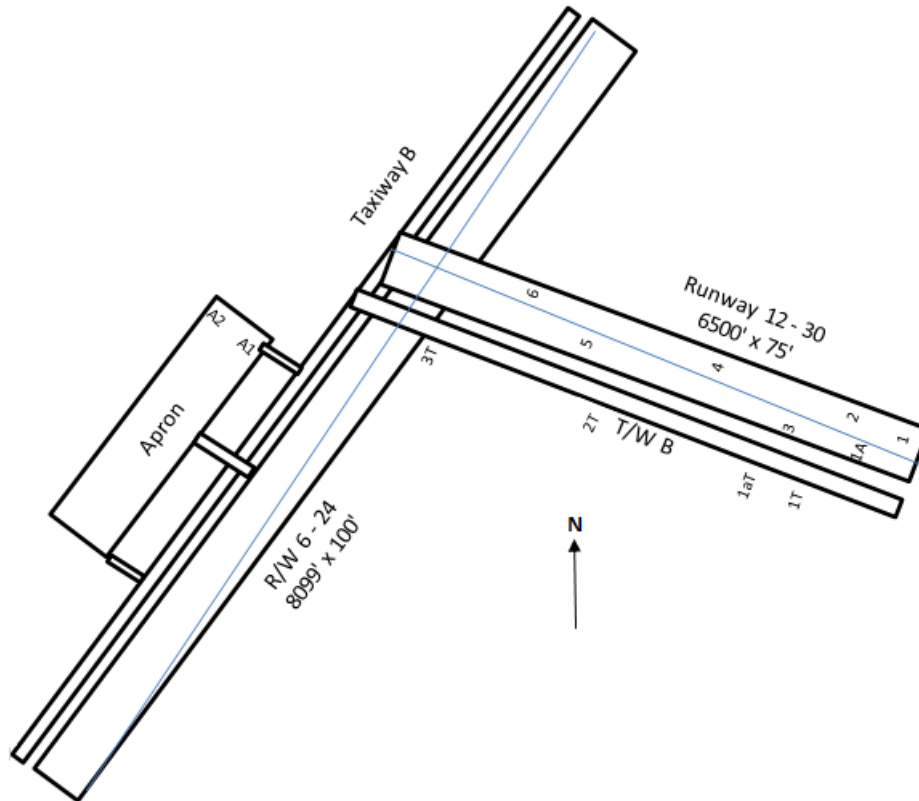
**Figure 4. Borehole Locations at Sierra Blanca Ruidoso (SRR)**

In November, 2008, the University of New Mexico (UNM) produced a report for the New Mexico Department of Transportation (NMDOT) – Aviation Division on the analysis of boreholes taken from the runways, taxiways and aprons at Sierra Blanca Ruidoso (SRR). The data consisted of asphalt concrete, base and subgrade thicknesses, generalized material compositions and California Bearing Ratio (CBR) for the materials underlying the pavement. In their analysis, samples from 13 boreholes were taken, and their locations are shown in Figure 4.
